TECH BULLETIN
SPRING-BRAKE / CENTER ADAPTER
Clarification of Cosmetic Imperfection

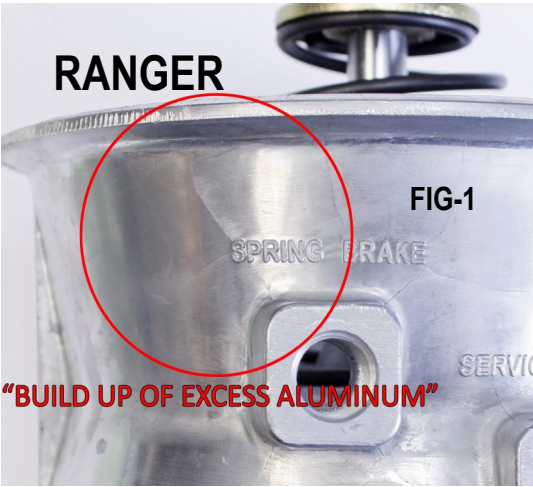
This notice is intended to clarify a visual [mark] that can occasionally appear on the surface of our spring-brake aluminum center adapters. Including OEM's. Fig-1

THIS [MARK] IS A CHARACTERISTIC THAT IS TYPICAL OF ALL ALUMINUM CENTER ADAPTERS AND IN NO WAY IMPACTS THE DESIGNED STRENGTH OF THE ADAPTER. THESE ARE NORMAL [MARKINGS].

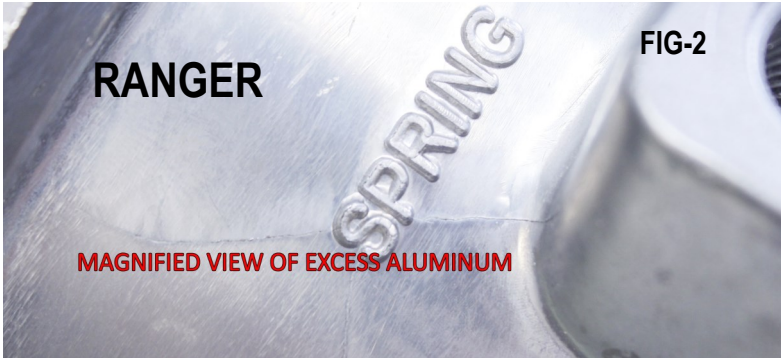
In Fig-2, you can see a magnified view of this CHARACTERISTIC. Which, in fact, is caused by a simple surface scratch in the mold. When the aluminum casting is removed from the mold this scratch causes a tiny amount of excess or build-up of aluminum that mirrors the scratch from the mold.

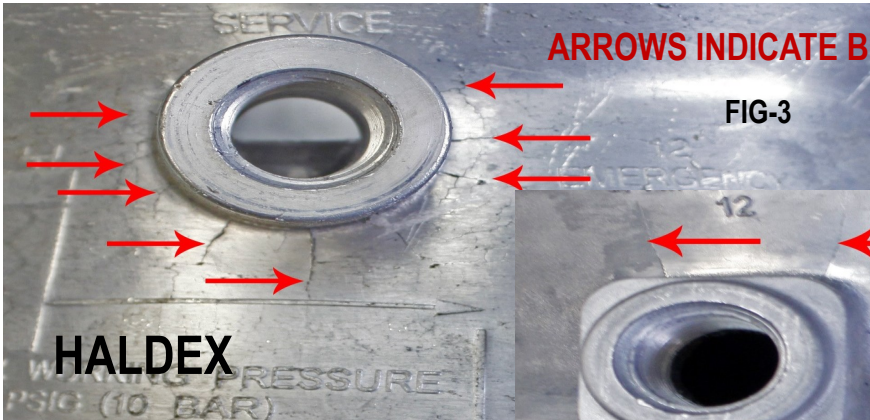
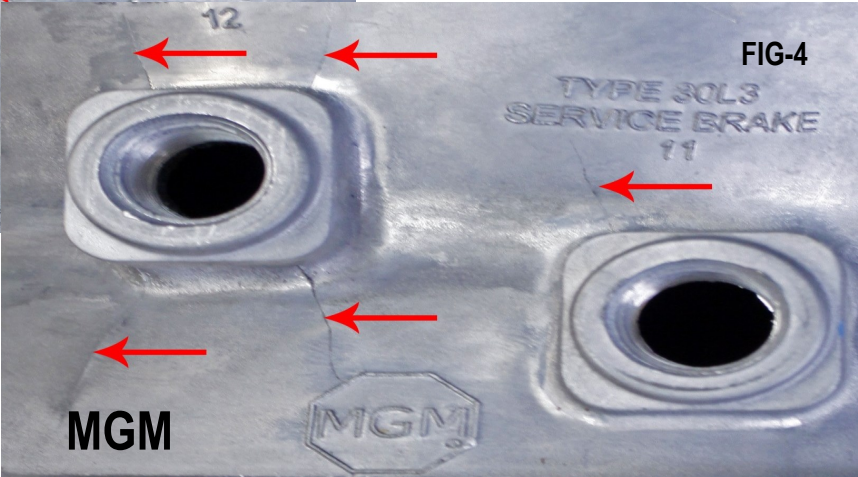
In Fig-3 / 4, you can see that these [markings] are common to all ALUMINUM CENTER ADAPTERS as evidenced by the two OEM-sample photos below...

ARROWS INDICATE BUILD-UP OF EXCESS ALUMINUM
